CASE STUDY

THICKENER TANK UPGRADE

OLYMPIC DAM, AUSTRALIA

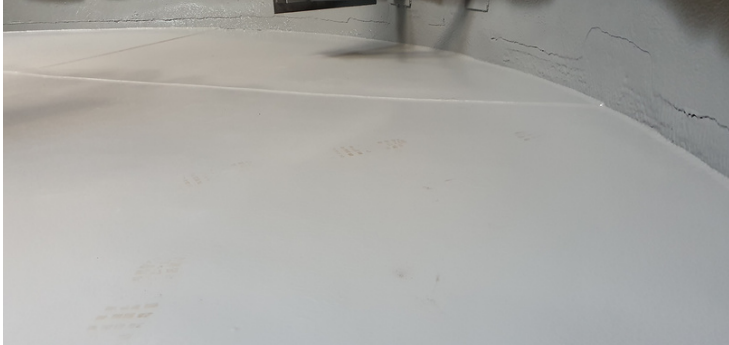
The Rake Arm and Rake Arm Components in the thickener tank had previously been subject to high abrasive wear by the abrasive slurry. The operation of the rake arms is a mechanical movement through an abrasive cargo that is very wearing on protective coatings. The Tufflon-P90's smooth surface finish and high abrasion resistance will result in an increased service life. Therefore, Tufflon-P90, a spray polyurea elastomer, was applied to protect the asset from corrosion and abrasion.

Blast the surface

Tufflon-P90 - 3000µm

Tufflon-P90 - 6000µm

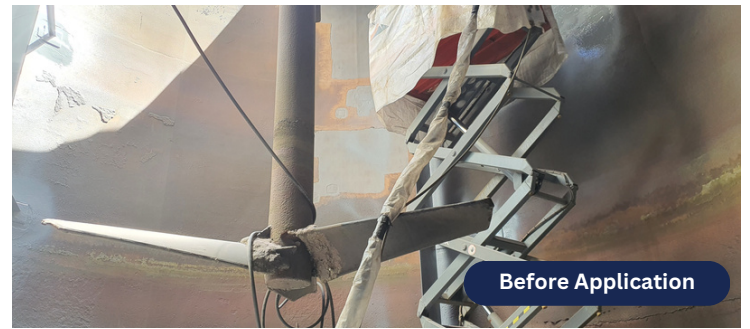
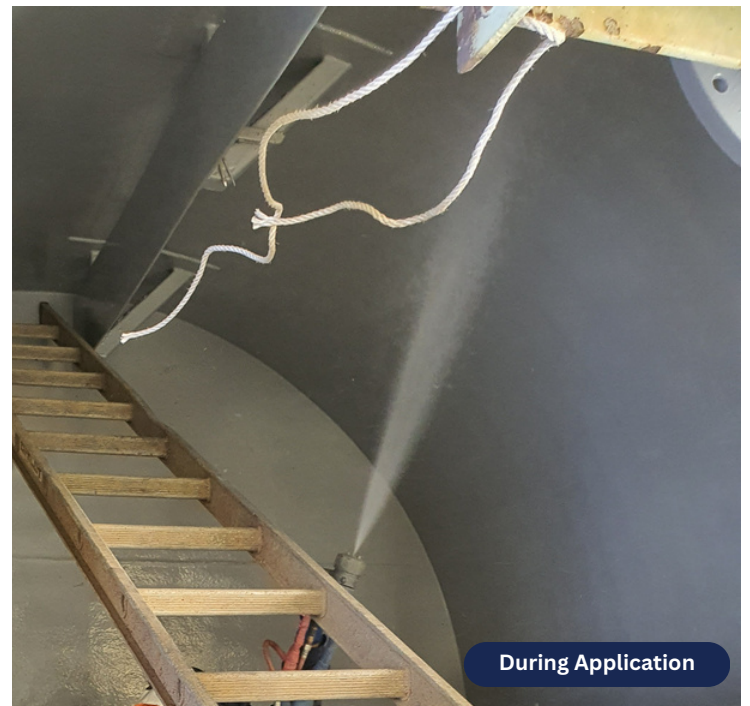
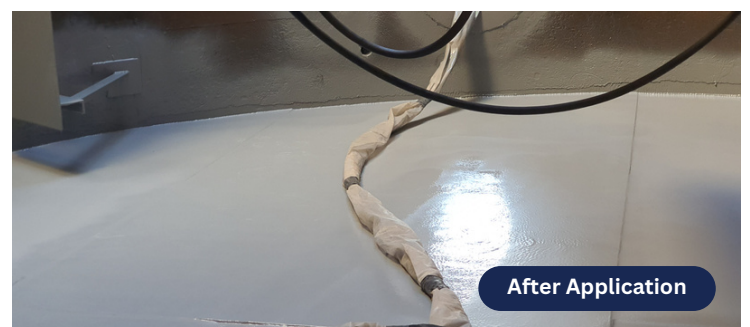
The specified protective coating system provided an expected service life of 4 years, and the solution worked efficiently and effectively and is still performing at a high quality level. The general recommendations for future projects are to use Tufflon P90's high build and abrasion-resistant characteristics to protect steel assets in the mining industry. The ease of application and speed at which polyurea can be constructed to an exceptionally high DFT makes Tufflon-P90 uniquely positioned to solve maintenance problems related to the protection of steel involved in highly abrasive mining processes.
