CASE STUDY

KENNY'S FOREST FLYER

DREAMWORLD, AUSTRALIA

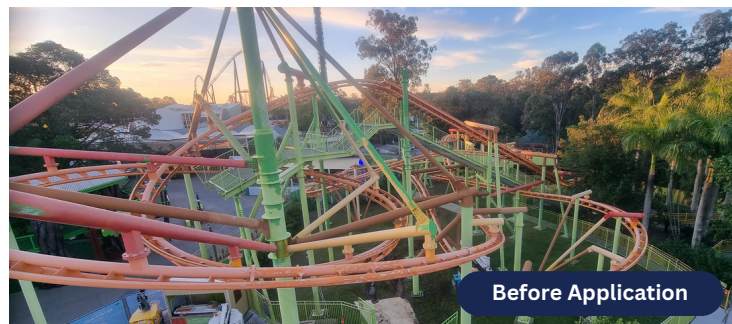
Before Application

LiquiMix recommended a system for repairing corroded steel and a maintenance system for application over the preexisting coating system. The system for corroded steel required surface preparation with a bristle blaster and the application of a three-coat system of two coats of Metalox-GC450 (a high-build epoxy protective coating) and a topcoat of Opalon-S30 (a decorative, high-gloss polyaspartic finish). The system for the preexisting coating requires a high-pressure water wash to remove the loose preexisting coating. Upon successful adhesion checks, the remaining coating was mechanically sanded, and the dust was removed. The existing coating was then overcoated with a topcoat of Opalon-S30, a decorative high-gloss polyaspartic finish.

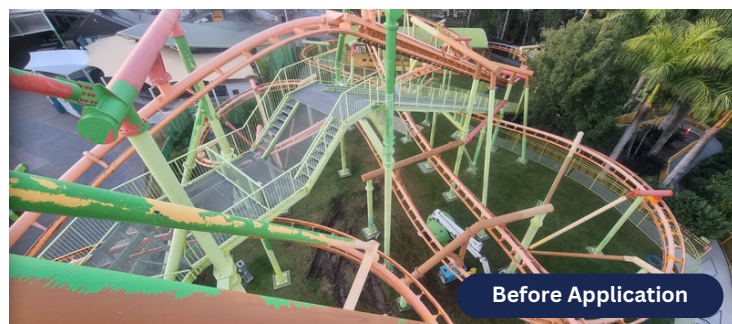
Before Application

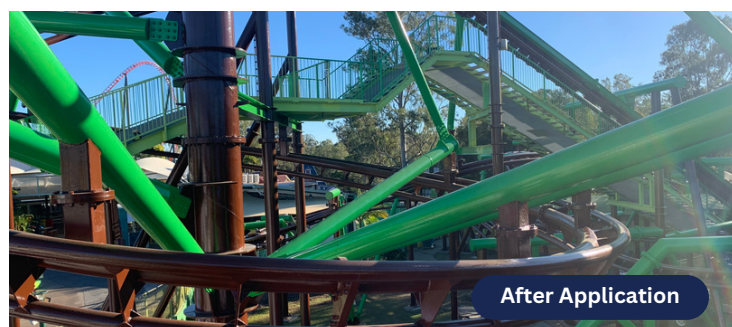
After Application

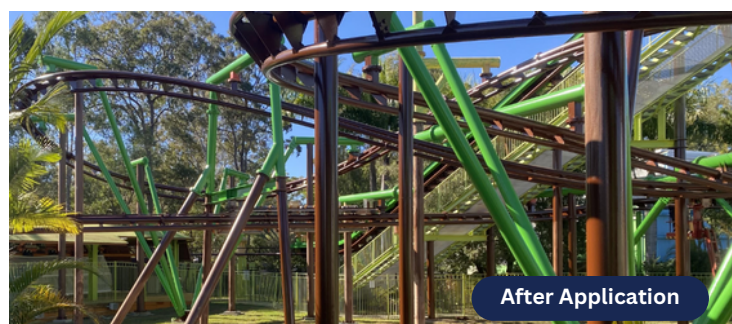
After Application
