Application of Asphalt over Tufflon P80 Membrane

CASE STUDY

PROJECT OVERVIEW: Commercial Surface Solutions

PRODUCTS USED: CiviloX LV100 Sealer, CiviloX HB200, Tufflon P80 Polyurea

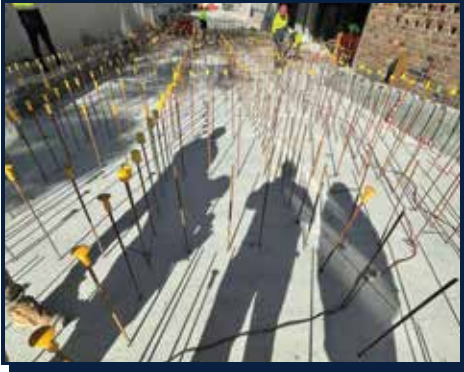
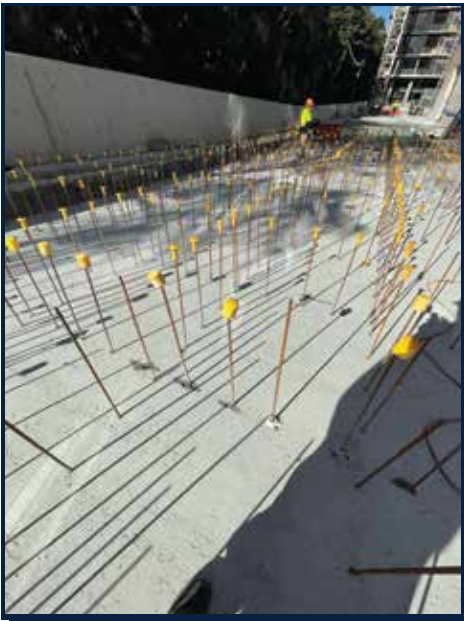
Waterproofing asphalt roads

Polyurea has been used as a waterproofing beneath hot asphalt, Bridge decks, car parks and road decks. The asphalt is used as a wearing sacrificial top layer.

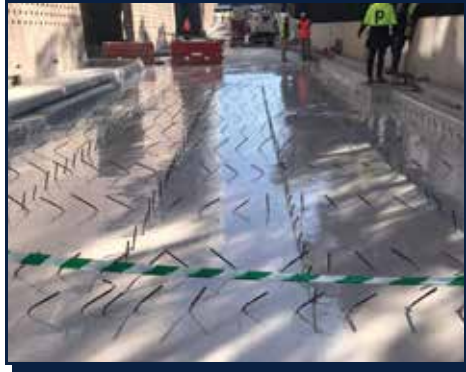
High temperature tolerance - short-term,
- Fresh asphalt placed at 140 - 180 °C,
Can deal with short-duration thermal spikes.

Seamless, fully bonded membrane -
mono lithic, joint free membrane.
Eliminates failures due to vibration found
in sheet membranes.

High Tensile strength and elongation -
Deals with concrete shrinkage, thermal
cycling and vibration from traffic.

Fast cure - meets need for fast construction.

Epoxy primer resistant to heat

- 1 coat of LV 100 sealer coat (4m²/L) instead of 2 coats
- 1 coat of HB 200 (DFT : 200µm)
- Spray coat P80 (DFT : 2-3mm)

The monolithic, fully bonded membrane eliminated joints and laps, reducing potential water ingress pathways commonly associated with sheet membrane systems.

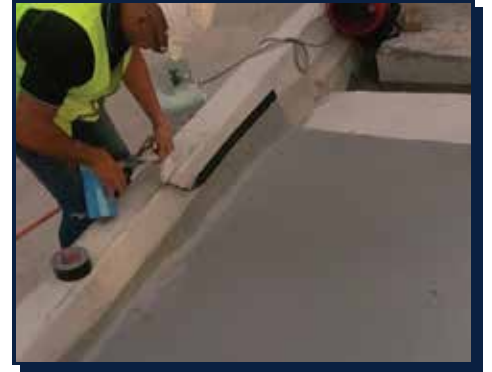
The polyurea waterproofing system installed beneath the asphalt driveway in July 2022 has performed as intended during and after asphalt placement. The membrane successfully withstood short-term exposure to hot asphalt temperatures (approximately 140–180 °C) without visible degradation, blistering, softening, or loss of adhesion.

No cracking, splitting, or delamination of the polyurea membrane has been observed, indicating effective tolerance of thermal shock during asphalt placement.

The system has accommodated substrate movement, thermal cycling, and traffic-induced vibration without distress, consistent with the high tensile strength and elongation properties of the polyurea.

The epoxy priming system (LV100 sealer and HB200 primer) maintained adhesion and stability during heating, confirming suitability for use beneath hot asphalt.

The fast cure characteristics enabled efficient construction sequencing, with no delays to asphalt placement.

Applied in July 2022 - and it has been in service for 4 years without issues.
